## **PIPELINE INVESTIGATION REPORT**

**P02H0052**

### **REFINED PRODUCT PIPELINE RUPTURE**

**TRANS-NORTHERN PIPELINES INC.  
273.1-MILLIMETRE-DIAMETER MAINLINE  
KILOMETRE POST 63.57  
NEAR SAINT-CLET, QUEBEC  
07 DECEMBER 2002**

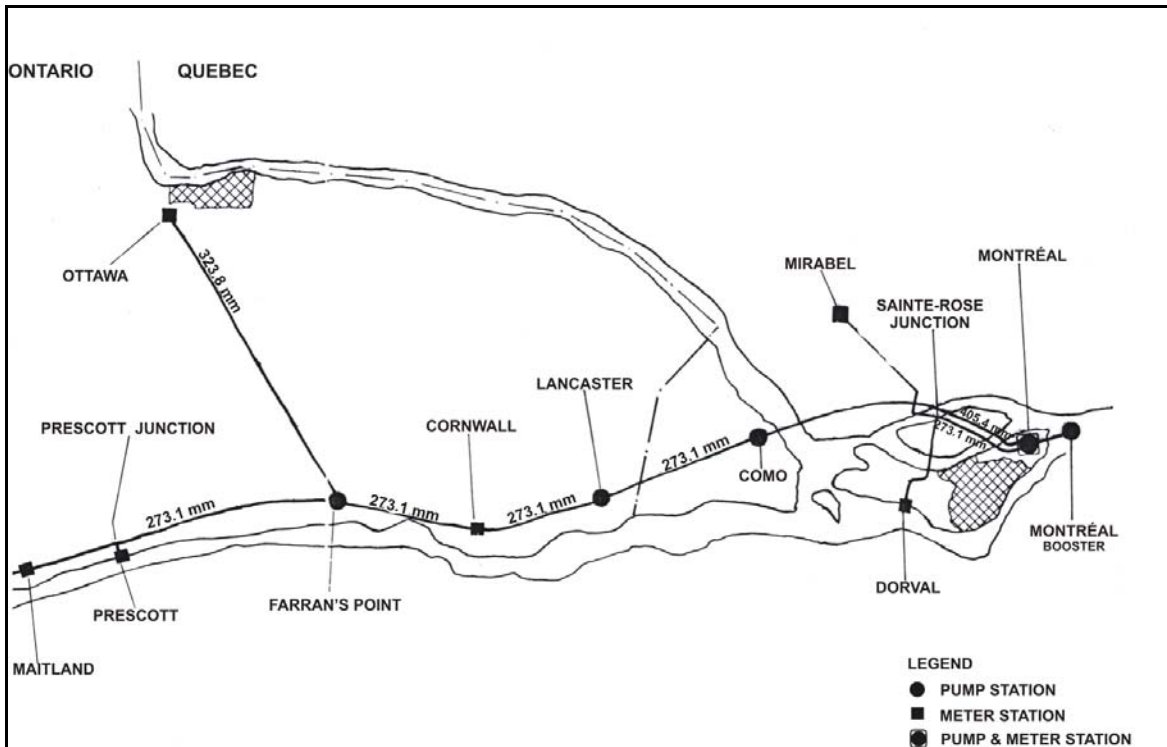
*Appendix A – Schematic of the Trans-Northern Pipelines Inc. Pipeline System from the Montréal Pump Station to the Ottawa Terminal*

On 07 December 2002, Trans-Northern Pipelines Inc. (TNPI) was delivering refined petroleum products from the Montréal, Quebec, refining basin into the Ottawa, Ontario, terminal storage facilities. This movement of product had originated from the company's Montréal pump station, with the pipeline pressure then being boosted at the Como, Quebec, and the Lancaster and Farran's Point, Ontario, pump stations (see system schematic in Appendix A).
